## If only life was that simple...

# White Elephant

## Restoration

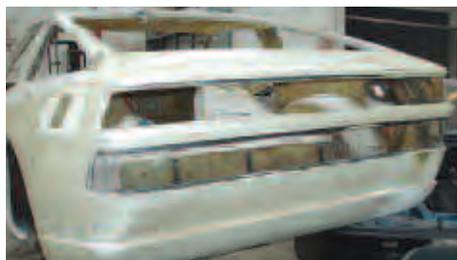
Although working hard to keep PW's old chariot as original as possible, I also decided to remove the aerial from its original mounting position on the nearside rear wing and install an internal aerial within the roof lining. This isn't an aesthetic move, but purely a common sense one. The fact is, the fibreglass is so thin along the rear quarters that if the aerial was to catch on something immovable it could be very easily ripped out, leaving us with the prospect of an awkward future repair job. So the original location hole was to be patched and filled and the rear corners strengthened. There was also an issue towards the front of the shell, where the old 420 Sports Saloon prototype nose had been bonded on. The fibreglass here was starting to come away and split quite badly, so some intensive work would be required to bring this area back up to spec'.

More worryingly, inside the tunnel where the manifolds ran close to the side of the bodywork, there were signs of heavy scorching. In certain areas the manifolds had actually been touching the front end of the tunnel, and we figured for longevity that by cutting a couple of recessed access panels in this area, we could assist the airflow around the manifolds.

At the same time this might also enable us to gain access to the two rear plugs of the Holden V8, which thus far had been impossible to get at. The carefully cut access panels gave us over ten millimetres of additional clearance and should certainly be a major improvement. We will cover the cut-outs from the inside with stainless, ceramic-coated covers which will be secured by way of captive nuts. These covers in turn will eventually be trimmed up with two pieces of Velcro-backed carpet for ease of removal.
